**Water Vole Conservation and Management:
Lessons From Four Case Studies**

Aston University

December 2016

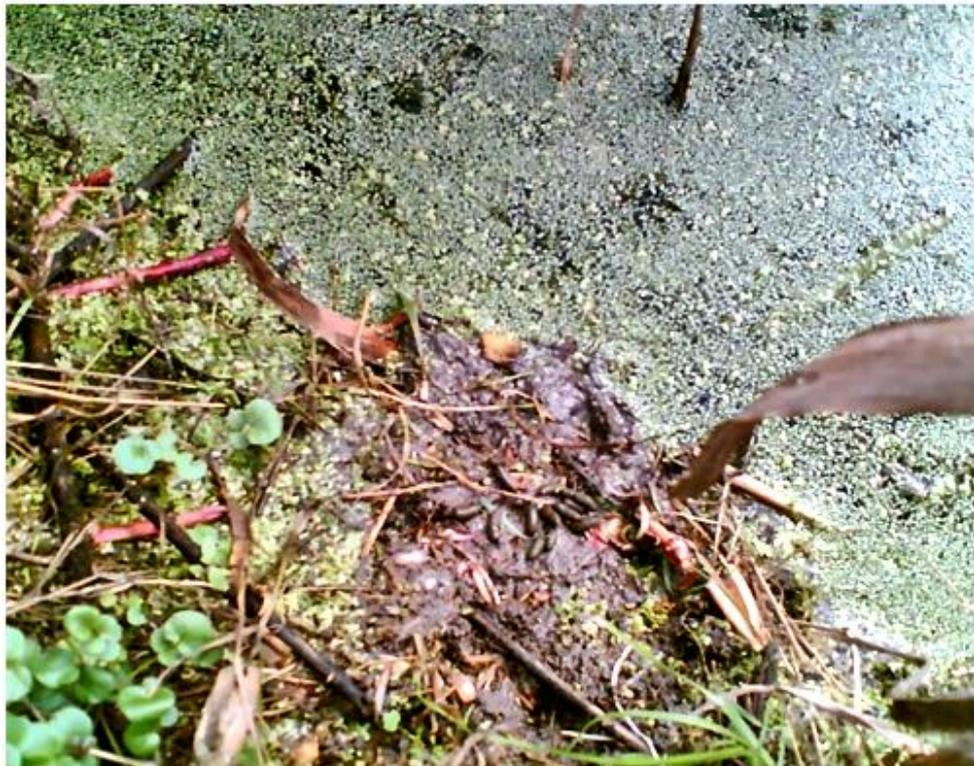
Fig 3.2 Water Vole Latrine

Water vole droppings (Fig 3.2) are deposited near to the burrows, the droppings in a latrine can vary in number. Droppings are usually brown-green in colour and blunt at both ends. Their size is approximately 8-12mm and they have the texture of putty when fresh. Fine plant

material can be seen when the droppings are squashed, and they have no odour. In a latrine, droppings are trampled down and fresh ones deposited on top. Water voles also use the latrines for territory marking.

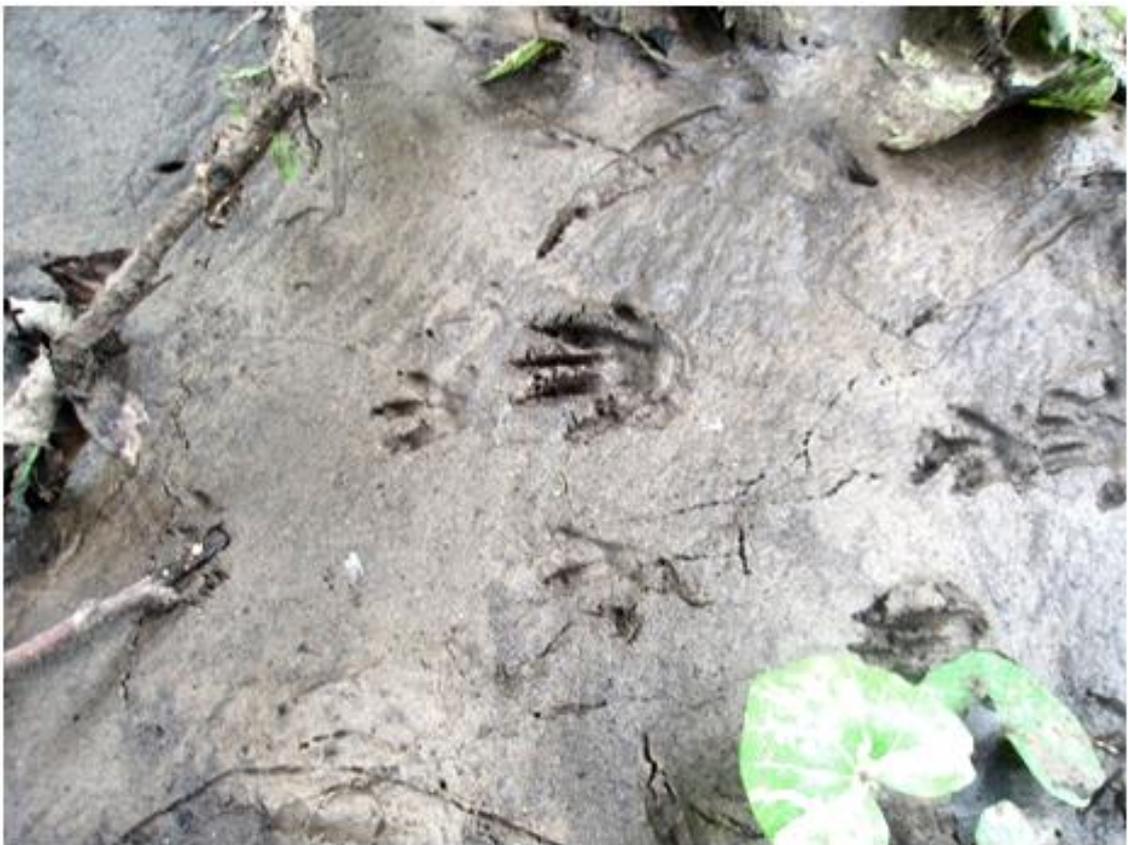
Fig 3.3 Water Vole Footprints

Often found in soft mud along watercourse edges, water vole footprints are 26-34mm (Fig 3.3). Water vole footprints are very difficult to distinguish from other rodents, especially those of the brown rat, unless the surveyor is experienced. It is not usually recommend that footprints are used as a positive confirmation of water voles presence, but as supporting evidence.

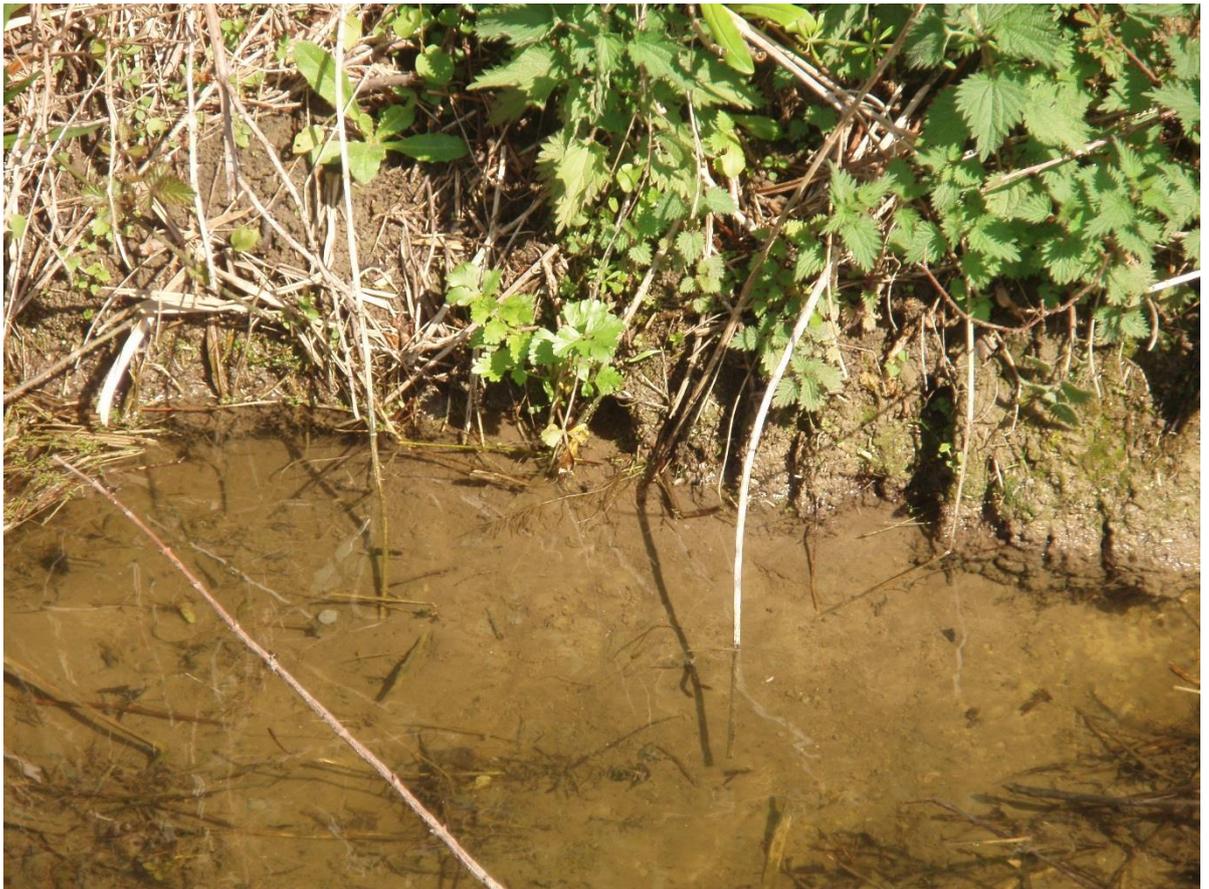
Fig 3.4 Water Vole Burrows at Water Level

Burrows are approximately 4-8cm in diameter, but can appear larger especially along the water's edge where entrances can erode (Fig 3.4). Other species which burrow/nest along water course to be aware of are rats (usually larger, 8-10cm, and can have a spoil heap outside), kingfisher, sand martins and sometimes mole tunnels which have been exposed. The burrows of other vole species are a lot smaller (between 2-3 cm).

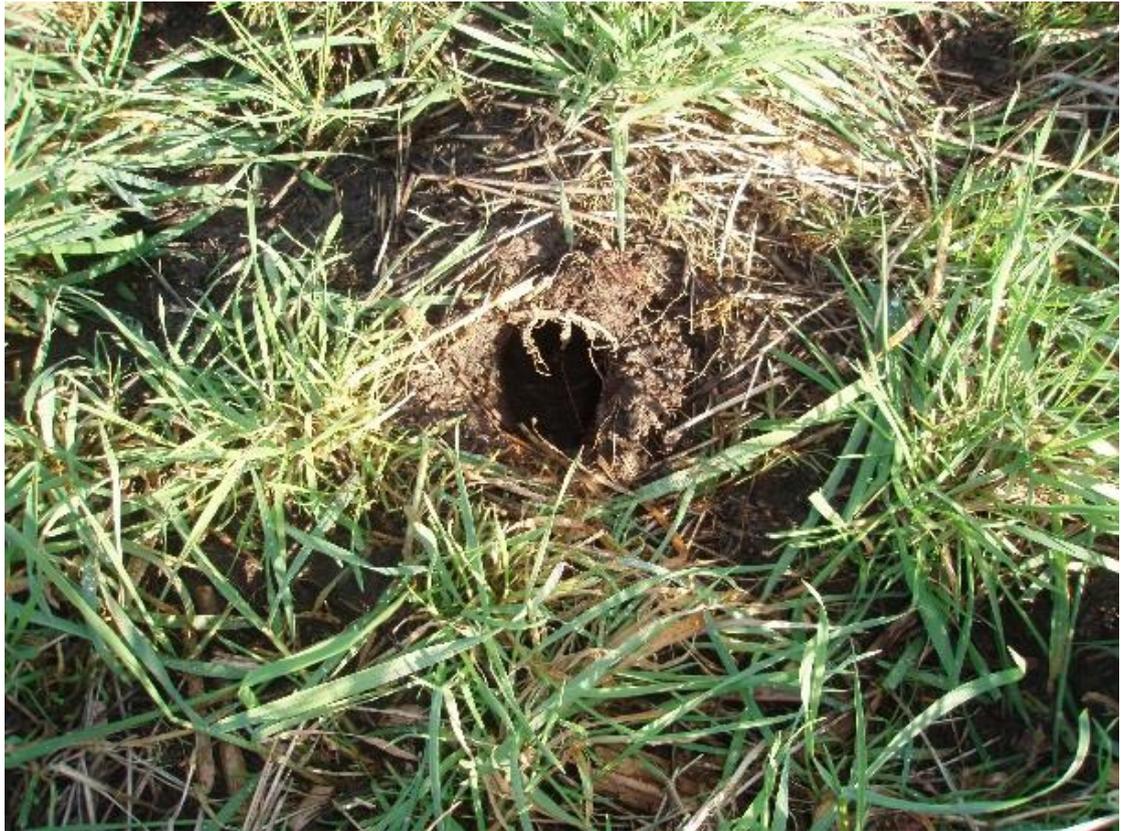
Fig 3.5 Water Vole Burrow High on a Bank

Water vole burrows often have two or more entrances, one at water level and ones higher up (Fig 3.5), especially where high water levels are experienced (see Sect 1.2.2).

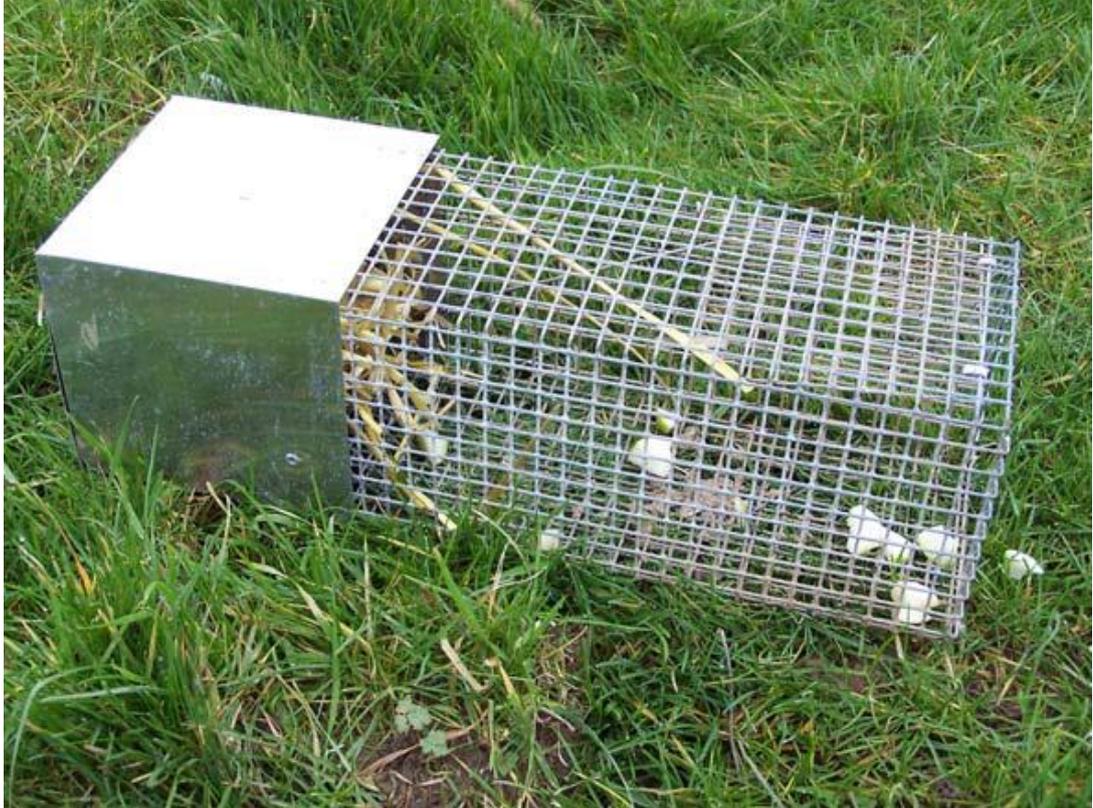
Fig 3.6 Water Vole Trapping Cage

and is protected from the elements. Food which contains a high water content (i.e. apples/carrots) is placed inside the cage. Small pieces of apple chips were also placed just outside the trap entrance to enhance the scent and entice the water voles into the trap.

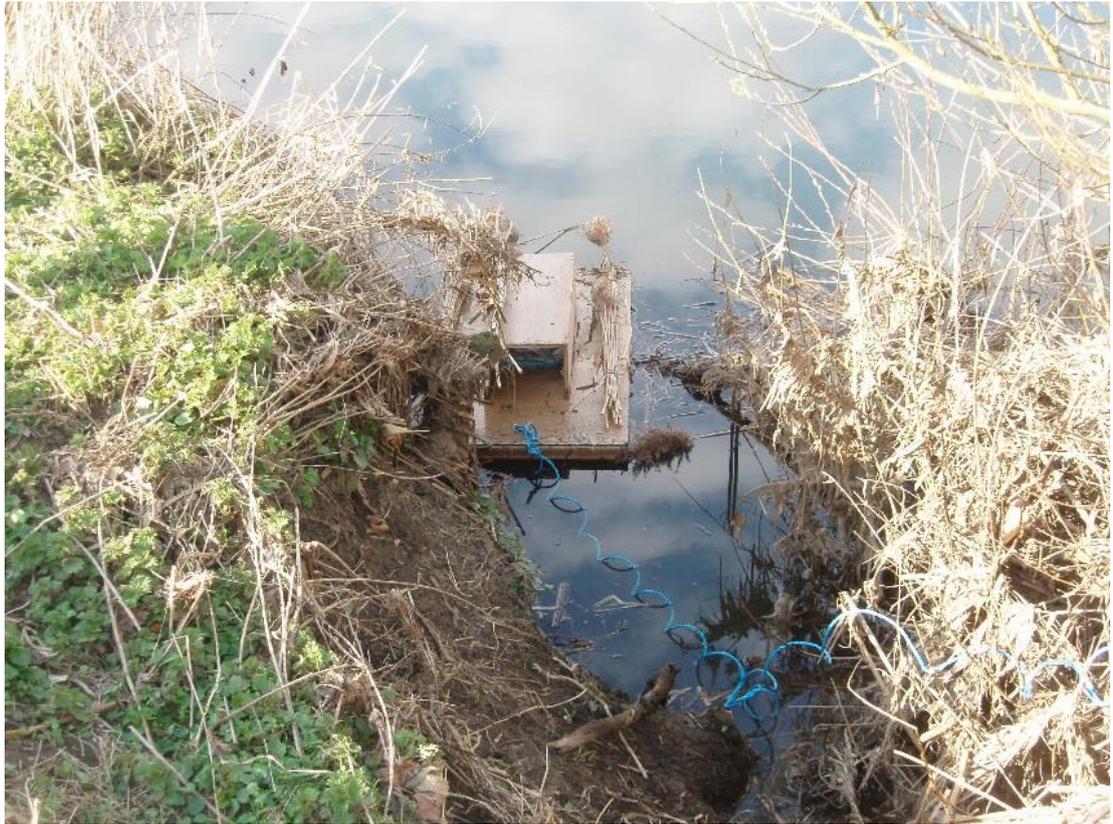
Fig 3.7 A Mink Raft

The idea of the raft is first establish if mink are within the area and then to trap them. As many mammals including mink are curious by nature, the animals will naturally investigate the tunnel, in the process imprinting their footprints onto the clay. Once the mink prints are identified, a baited trap is installed into the tunnel to replace the tray. The trap is a live capture trap, as only the mink are to be eradicated. The trap is checked a minimum of twice a day, dependent upon weather conditions (i.e the more extreme the weather conditions the greater the number of times traps are checked so no animal captured suffers unnecessarily). Any native animals captured (polecat/otter) are released, and the mink are disposed of humanely by a suitability qualified person, such as a game keeper.

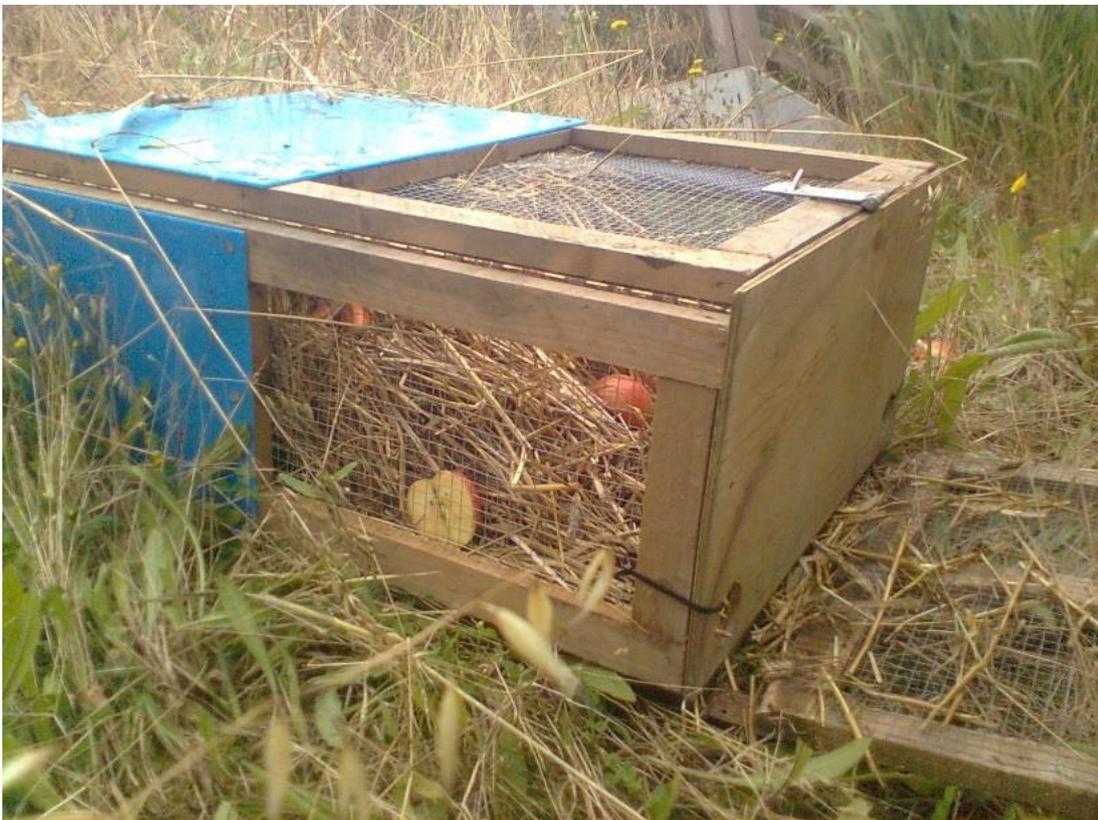
Fig 3.8 A Soft Release Water Vole Pen

The water voles for soft release are initially kept in pens (Fig 3.8). These pens are positioned around the water bodies of interest, approximately 100 m apart. Each pen is comprised of a wooden frame with chicken wire to keep the water voles in and any predators out, and have a section of uPVC or wood over a portion of one side to provide shade. The water voles are placed in family groups into each of the pens, with numbers varying depending on family size, but generally a maximum of ten so as not to crowd the pen out. The water voles are provided with bedding and food, which comprises carrots and apples to provide them with the necessary water content.

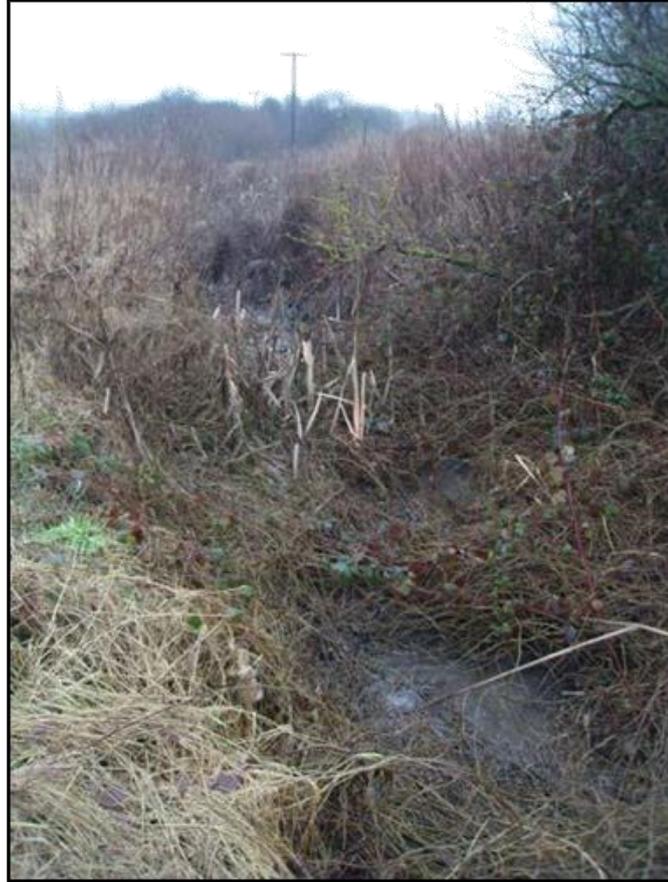
Fig 4.3 Ditch D1 Choked by Vegetation

The ditch connecting the lagoons, Ditch D1, started to the West within the scrub and hedgerow, and at the time of the survey was dry. It continued East, where it moved into the open land and was engulfed by vegetation, including reedmace figwort *Scrophularia nodosa*, great willowherb and bittersweet (Fig 4.3). Water was present at this point within the ditch.

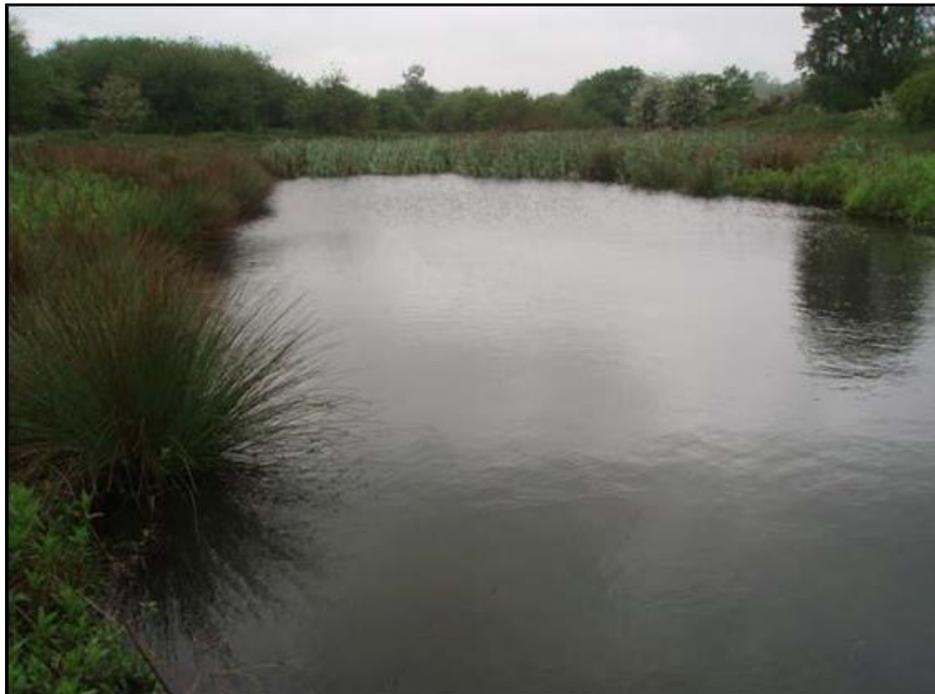
Fig 4.4 The Large Pool at Kirkby

The large pool was approximately 40m x 14m (Fig 4.4). The Southern edge had areas of bare ground with tussocks of soft rush/hard rush and reedmace, brooklime *Veronica beccabunga*, bittersweet *Solanum dulcamara* and duckweed *Lemna minor*. The Northern banks were completely dominated by tall ruderal species, and the Western section of the pool had been completely engulfed by a mixture of reedmace, rushes and great willowherb.

The survey (see Fig 4.5) found signs of water vole activity only on the Southern bank of the large pool (P1) (Fig 4.4), where four fresh latrines and several grazing sites were recorded along. A significant constraint to the completion of a full survey was deep siltation to areas to the West of the large pool, which was colonised with dense vegetation, which was deemed too unsafe to enter. The Habitat Assessment found Ditch D1, all four lagoons and Pond P1 assessed as green habitat. Ditch 2 (west) was classified as amber due to loss of standing water due to being choked by vegetation and shaded. Ponds 2 and 3 had limited food source due to the size. Ditch D2 (east) was red due to being dry and shaded resulting in bare ground. The River Erewash was assessed as red due to heavy shading resulting in insufficient food sources.

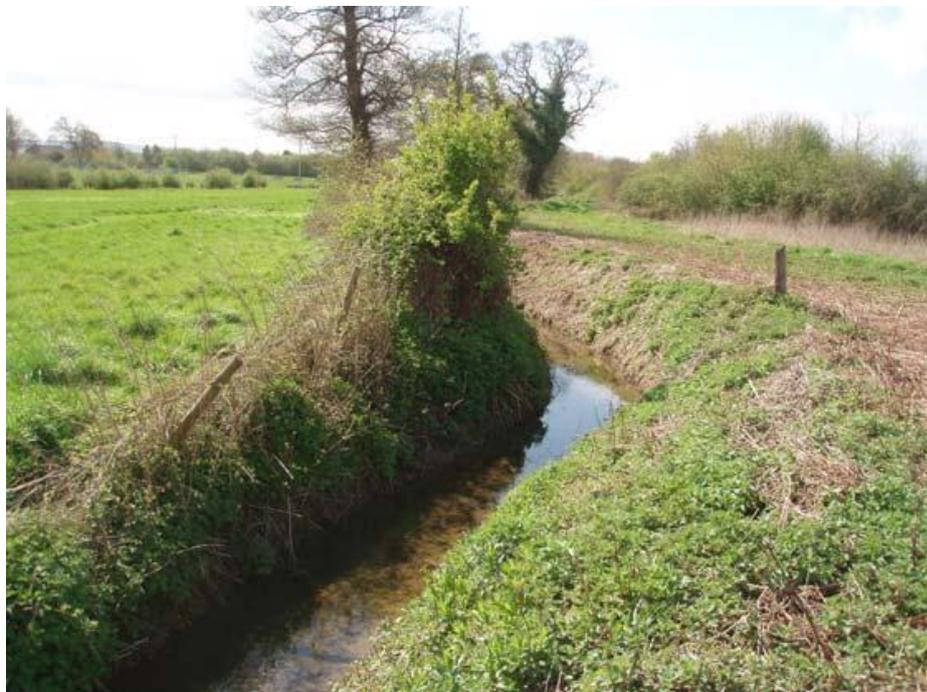
Fig 4.11 Ditch Forming the Boundary to Netheridge Nature Area

The site was almost completely surrounded by a wet ditch separating the site from the adjacent farmland and residential gardens (Fig 4.11). The ditch was approximately 3m across at the top, reducing to 1.3m at the channel. Banks were steep on both sides and between 1 and 1.5m high.

The water depth ranged from 0.3m to 0.4m, with a layer of silt at the bed. The banks on the site side were dominated by tall ruderal species at the top with scattered emergent/marginal vegetation at the water's edge. Species included meadowsweet, cow parsley, nettle, lesser celandine *Ranunculus ficaria* and watercress *Nasturtium officinale*. The farmland side of the ditched had scattered trees and hedgerows in places, which created a more shaded bank with areas of bare ground. To the Northwest and South of the site the ditch became overgrown by dense impenetrable bramble *Rubus fruticosus* agg..

A levelling survey was undertaken to ascertain the existing profile the chosen ditch section. This showed, as with the botanical description, that the ditch banks had steep banks on the West and East sides. The farmland (East) side had a defunct hedgerow and scattered trees abutting the bank. The proposal for this side of the boundary was to infill gaps in the hedgerow to improve habitat connectivity. Therefore, only the West side of the ditch was to be re-profiled. Fig 4.11 shows the ditch prior to re-profiling.

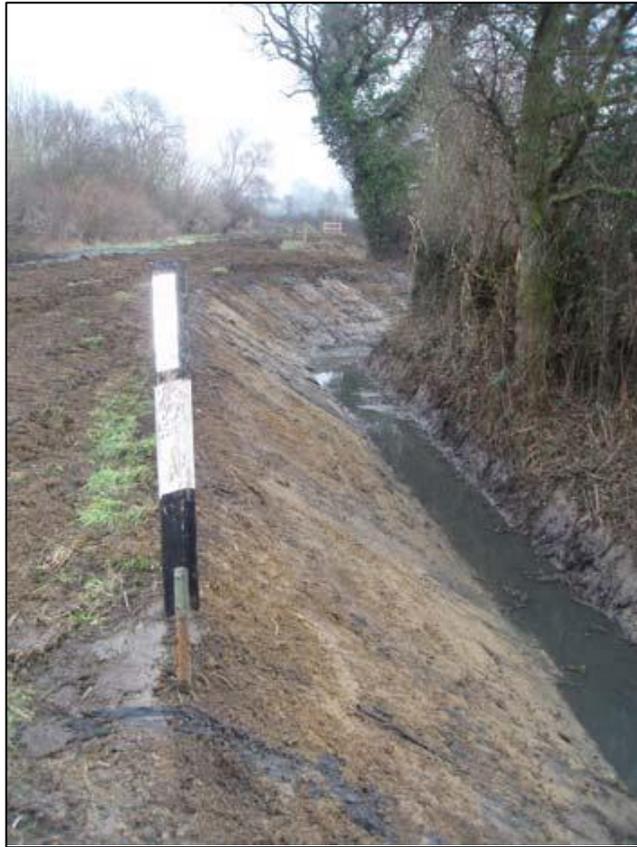
Fig 4.15 The Netheridge Ditch following Re-profiling

The ditch redesign reduced the steepness of the Western bank to provide an optimal habitat potential for water voles. The bank would be re-profiled to a 45 degree slope (Fig 4.15) with a shelf in some sections at the base to create a larger bank surface area for water voles to burrow into. Marginal vegetation will also be established along the shelf area. The ditch was also to be de silted during the re-profiling work. It was planned that the excess spoil from the re-profiling would be used to create bunds along the ditch, these however were sited a short distance from the ditch to avoid any shading to the area. The purpose of the bunds was to provide areas of refuge for the water voles in times of flood.

With the formal approval of Severn Trent Water and the Internal Drainage Board (IDB), funding was obtained and the enhancement works were undertaken and completed in January 2010. Fig 4.15 shows the ditch after re-profiling.

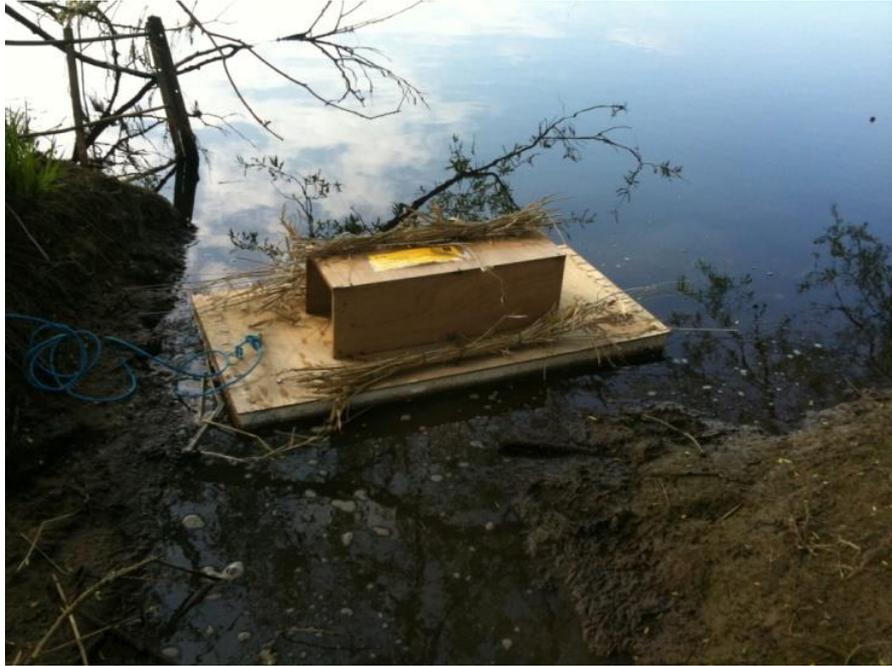
Fig 4.19 Mink Raft on the River Avon

Throughout this project, with the aid of local farmers/game keepers/anglers, mink control was undertaken on a regular basis, both upstream and downstream of Brandon Marsh along the River Avon – their location is shown in Appendix 5. The checking of the mink rafts was a very time consuming process. They had to be installed (Fig 4.19) in areas away from public access to minimise interference and at the best available locations (i.e. by potential den sites/near junction of watercourse), which were not always close or easily accessible.
